ST. EOM'S PASAQUAN COMPOUND

Condition Report and  
Recommendations for  
Repair and Maintenance

from a site survey  
conducted  
January 25 - 27, 1988

prepared for  
The Columbus Museum  
Columbus, Georgia

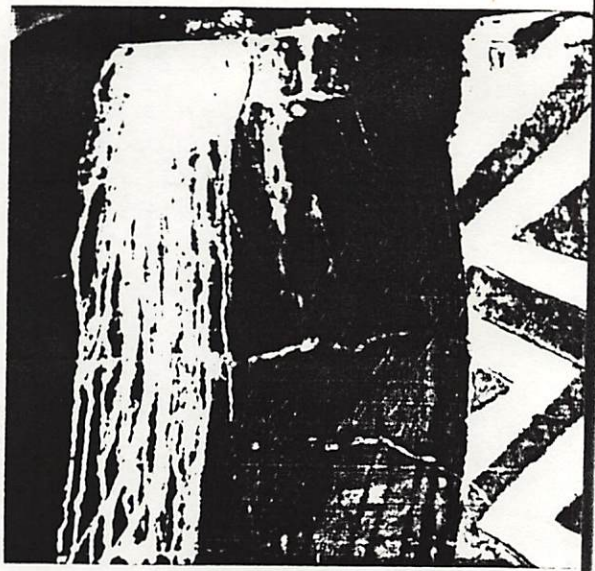
1. ARTIST ST, EDM  
2. TITLE ENTIRE TOTEMS SIWASSA + SIWASSA  
3. SIZE H. 9' W. 2 1/2' T.  
4. OWNER  
5. PROVENANCE ARTIST  
6. PHOTOGRAPHS ✓  
7. FRAME  
8. S. MARK AND MARKS

LIME RUN ON SIWASSA

9. DAMAGE AND LOSS:  
PUNCTURES  
LIME RUNNING  
TEARS  
CHECKS ✓ MAJOR FISSURE SIWASSA  
SURFACE DIRT LIME ACCUMULATION - BOTH

3. RECOMMENDED RESTORATION
- FILL CRACKS WITH HYDRALIC LIME
  - REPLACE LINTEL PANELS
  - REMOVE LIME
  - SEAL
  - RETOUCH

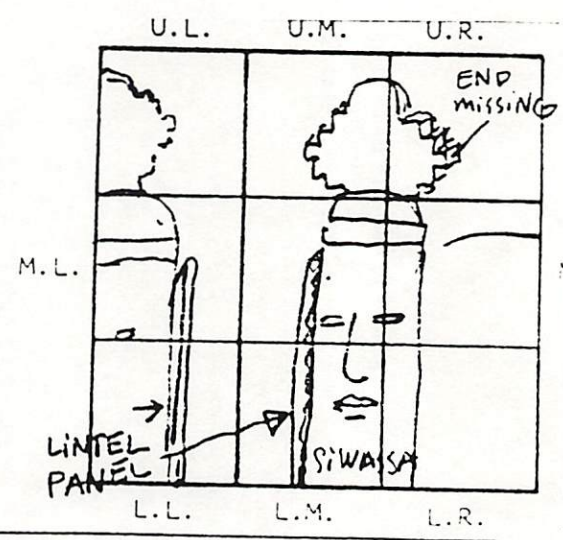
10. FLEXIBILITY  
11. FUNGUS OR INSECTS ✓ ROTTEN LINTEL PANELS - REPLACE  
12. PREVIOUS RESTORATION

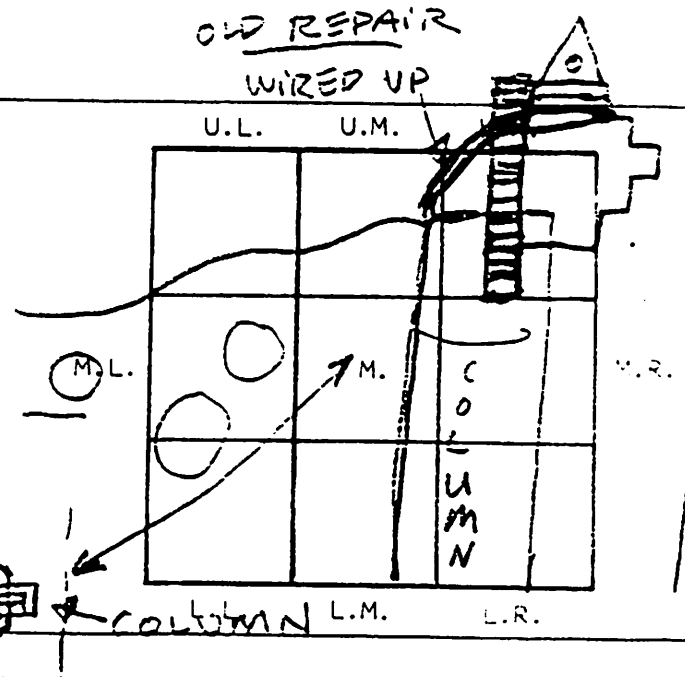
2. TITLE CURVED WALL BETWEEN #4 GARAGE - HOUSE

PUNCTURES - PLANTER - SEVERE  
- CRACKING

TEARS - SNAKE - CRACKING

CHECKS - COLUMN AT END  
OF WALL - VERY CRITICAL

SURFACE DIRT FALLING OFF

WALL FADING

13. RECOMMENDED RESTORATION
- RESTORE COLUMN TOP
  - PEGS + EPOXY
  - REPAINT WALL
  - RESTORE PLANTER

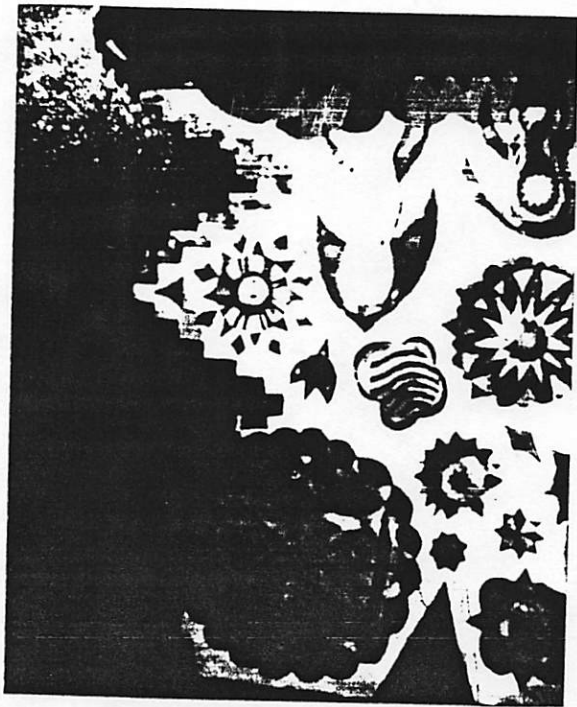
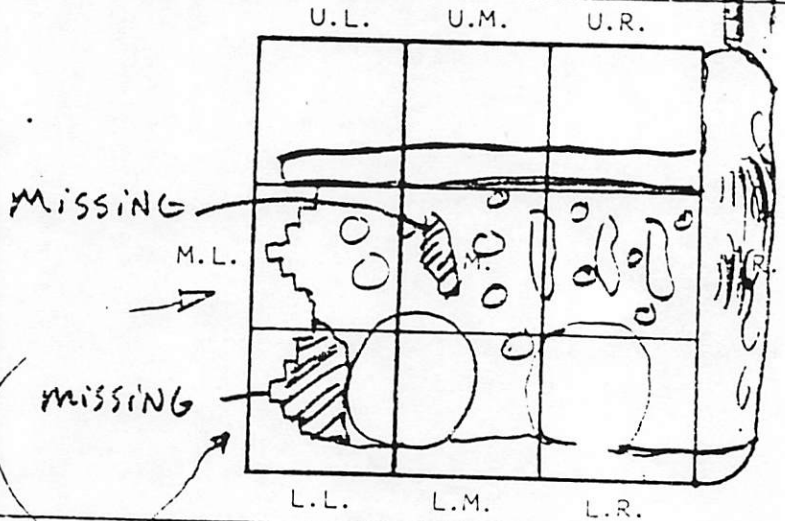
2. TITLE GAS TANK HOUSING

8. SUPPORT AND MARKS GAS TANK HOUSING  
. BACK FIN MISSING  
- RELIEF MISSING

13. RECOMMENDED RESTORATION  
- REPLACE  
- RETOUCH
