SPACES 1979 documentation, survey program of five California sites
Conducted by Don and Sharon Howlett

NAME	LOCATION
* Old Trapper's Lodge	Sun Valley, CA Los Angeles County
* Grandma Prisbrey's Bottle Village	Simi Valley, CA Ventura County
Possom Trot (dismantled)	San Bernardino County
* Art Beal's Nit Wit Ridge	Cambria, CA San Luis Obispo County
* Driftwood Charlie's World of Los Art	Winterhaven, CA Imperial County

CALVIN AND RUBY BLACK'S POSSUM TROT

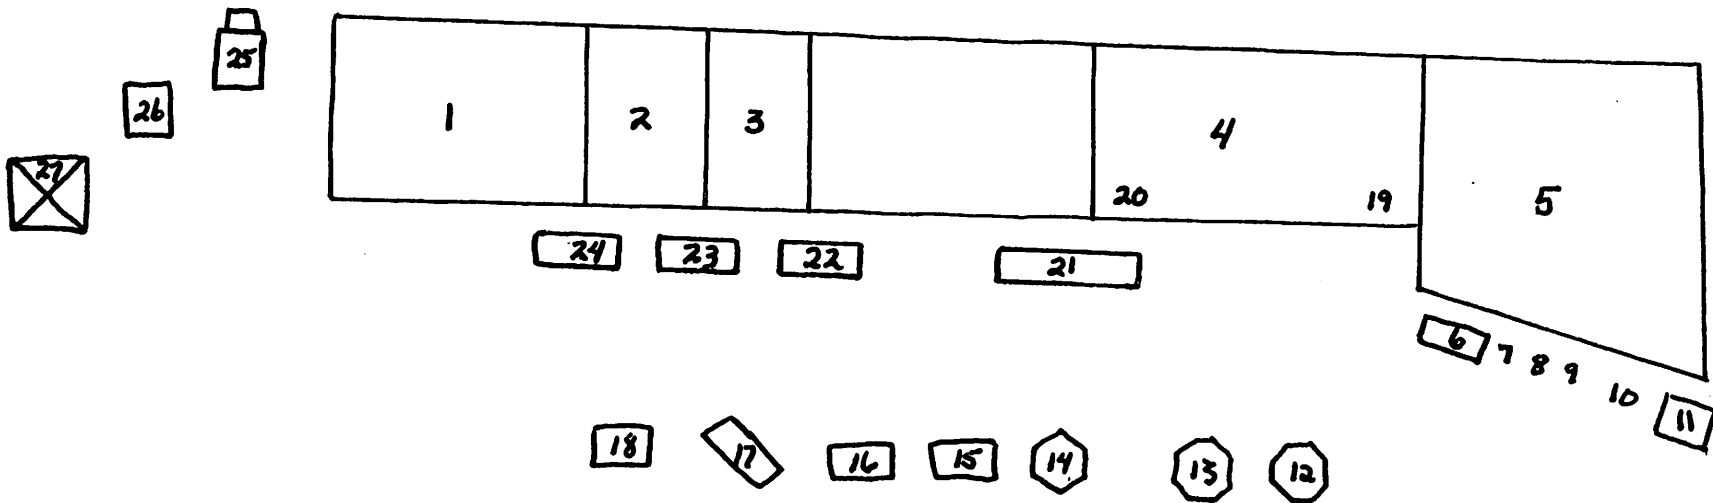
Calvin & Ruby Black's Possum Trot

1. Fantasy Doll Show
2. Stage Stop
3. Possum Trot News
4. Possum Trot Shop
5. Rock Shop
6. Hearse
7. Sharpening Stone
8. Gold Dry Washer
9. Palm King
10. Hi Ho Cowboy
11. Big Chief
12. Merry-go-round
13. The Skating Rink

14. "Grocery Girl" dancer
15. Helen
16. Rhoda
17. Ferris Wheel
18. Stage Coach
19. Covered Wagon
20. Roman Chariot
21. Totem Pole
22. Stage Coach
23. Hell's Cargo Stage Coach
24. Helen M. Covered Wagon
25. Water Shed
26. Well and Wind Pump
27. Shed
